# Section 2

## Water Management Situation in the Aral Sea Basin

## 2.1. Water Management Situation in the Amu Darya and the Syr Darya basins

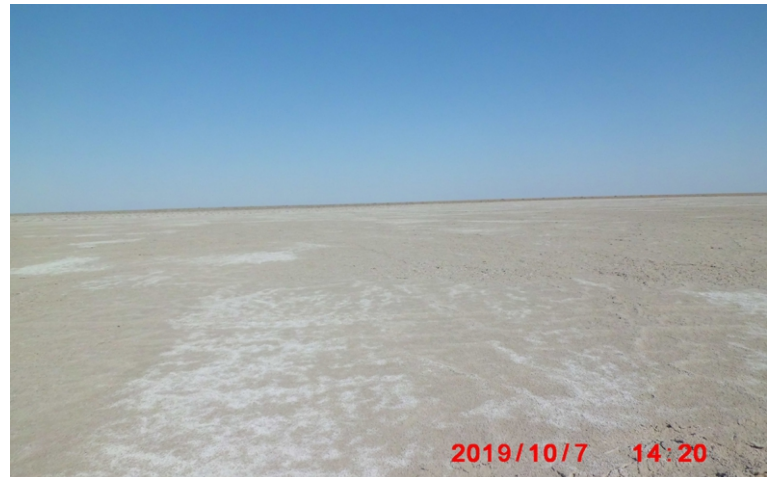
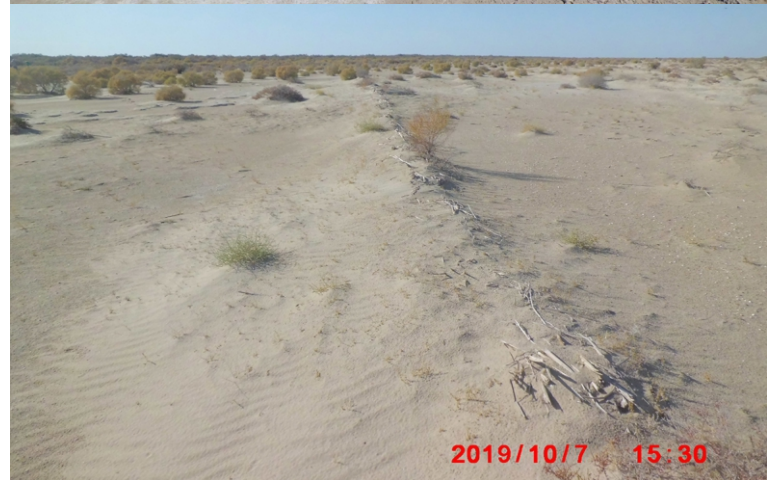
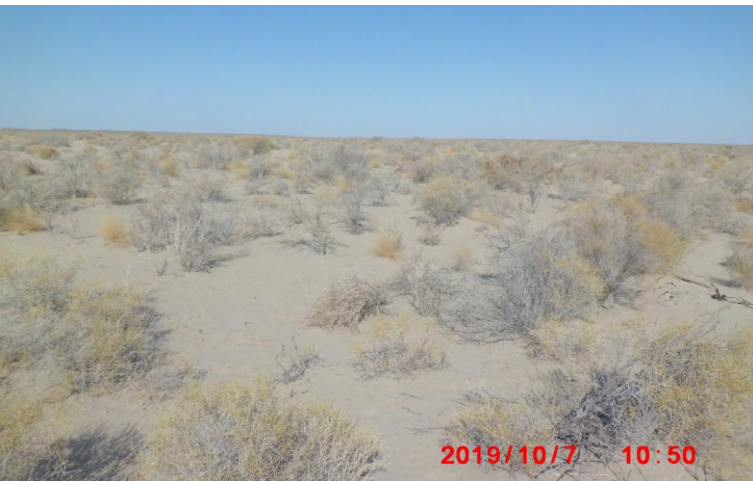
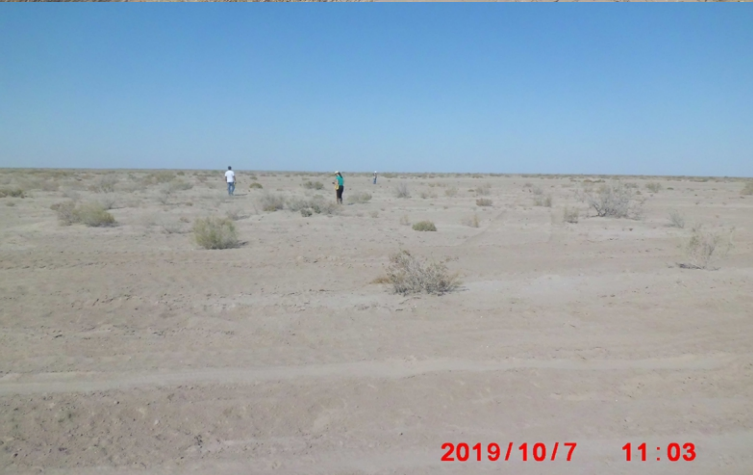
**Point 1107.** Landscape changes by sand dunes, 0.5-1 m high. The soil is sanded solonchak, with shells and stone inclusions.

**Point 1115.** Perennial saxaul (0.5-1.5 m) and young saxaul are observed. There is self-organized vegetation. *Halostachys*, *Kandym*, *Selinum*, *Aristida L.*, and camel's-thorn are also found.

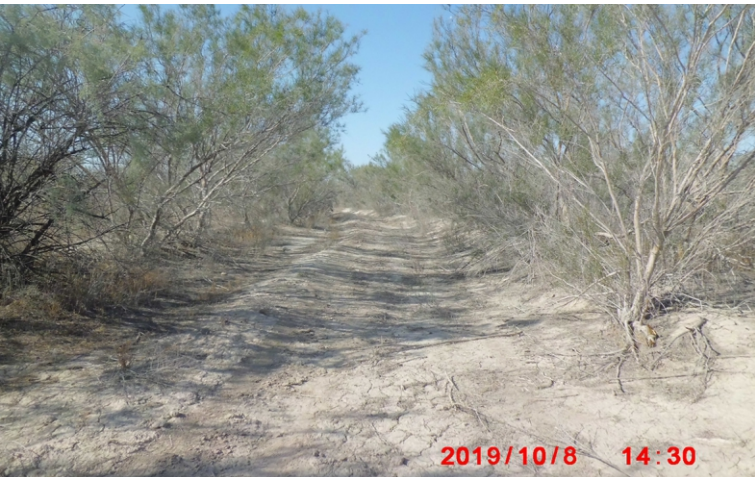
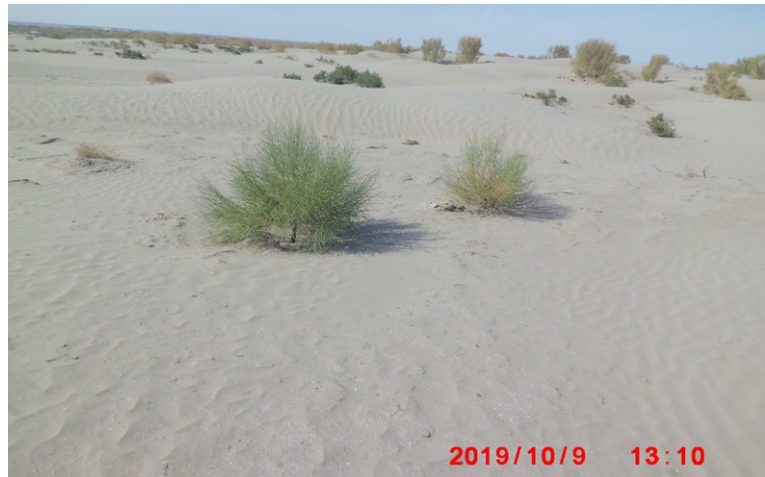
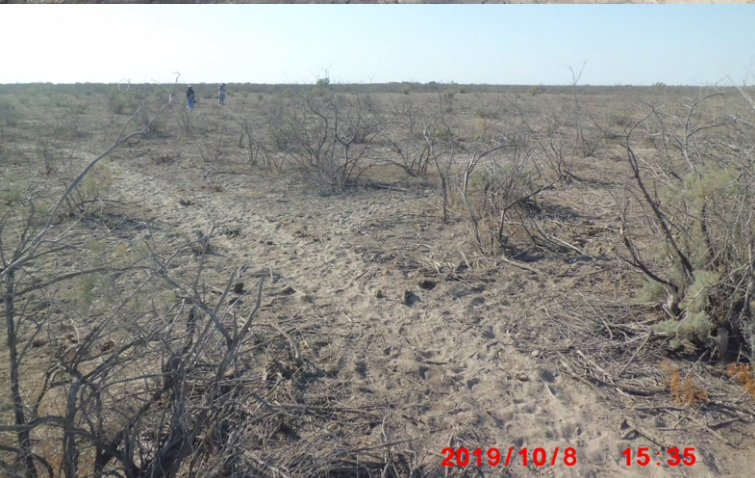
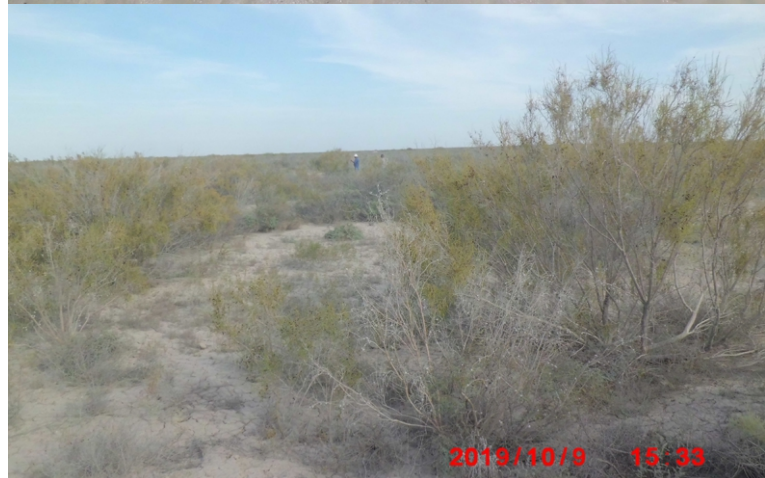
Further (**point 1243**), on the left bank of the former channel of the Amu Darya, rare perennial

saxaul and 90% dried-out tamarisk are found. The vegetation cover is about 50%. There is camel's-thorn. The relief is flat.

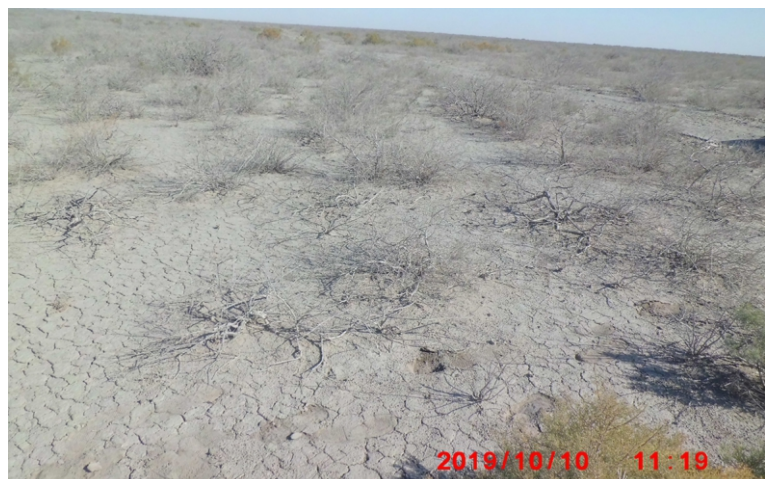
**Point 1388.** The relief is flat at the beginning of the route. The soil is black-colored sandy loam. The area has been flooded, with following overgrowth with tamarisk and, later, *Climacoptera Botsch* started to grow. Tamarisk has dried out on 70-80% of the area, and *Halostachys* (0.5-1 m) is also dried out.

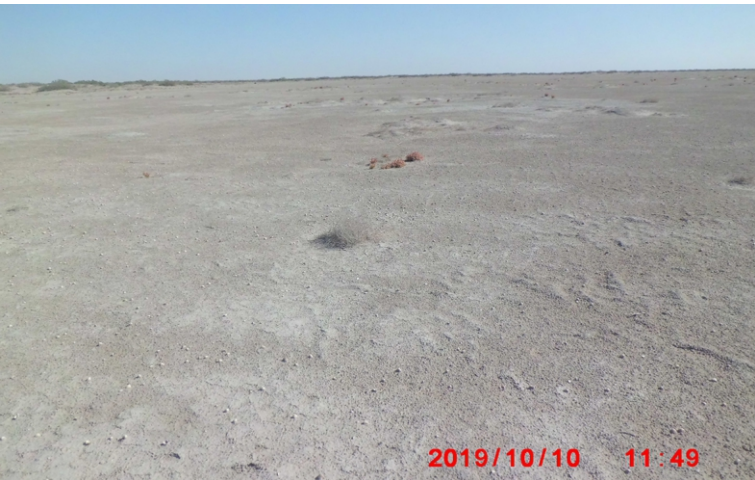
**Point 1392-1395.** Further elevations of the relief change from 0.5-1 m. There are sandy dunes; the area is open. *Climacoptera Botsch* and rare dried-out grasses are found.

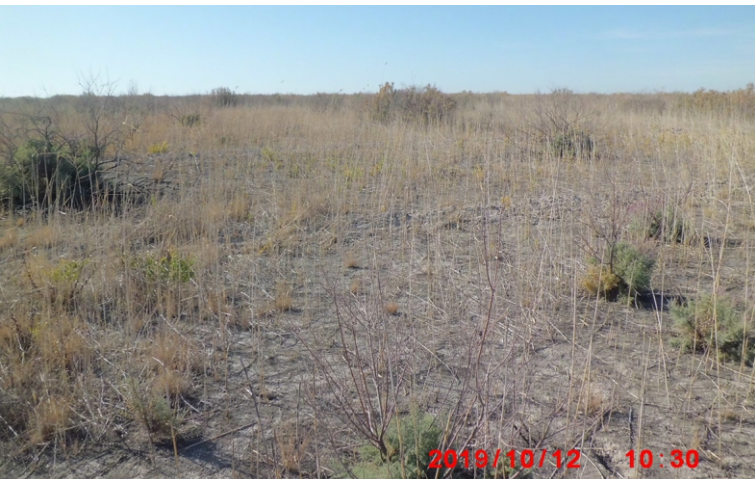
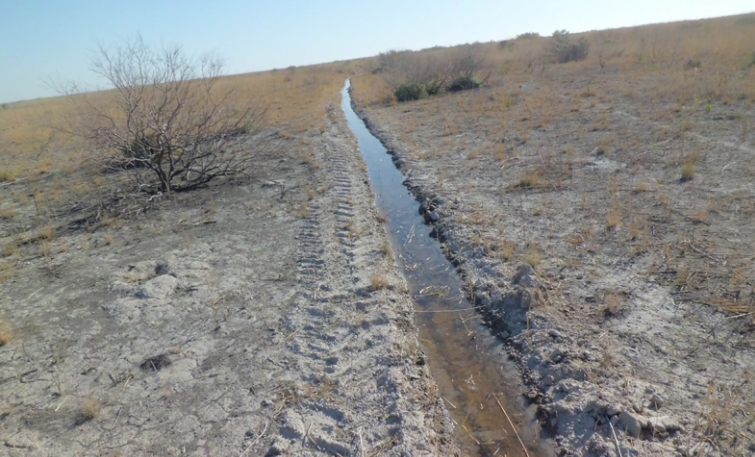
**Point 1443.** The relief is flat. Furrows are cut for sand accumulation. The area damaged from fire is overgrown with tamarisk. *Halostachys*, dense reed, orach and dried-out annual grasses are rarely found. The soil is crusted solonchak. The furrows were filled with water flowing from Rybache bay.

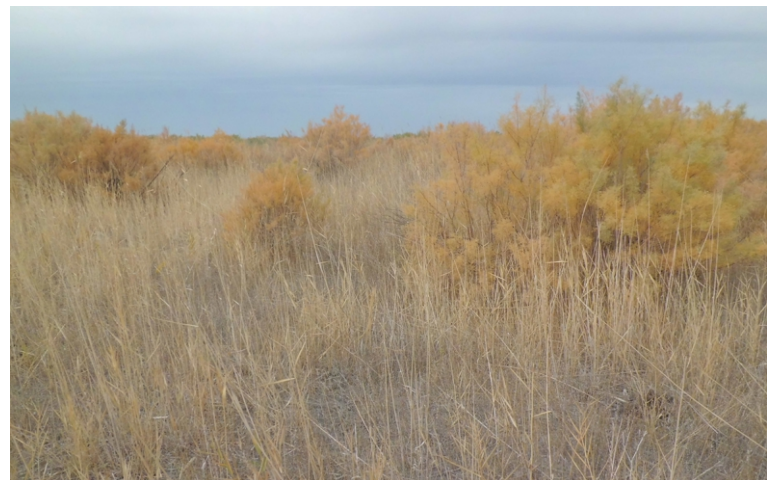
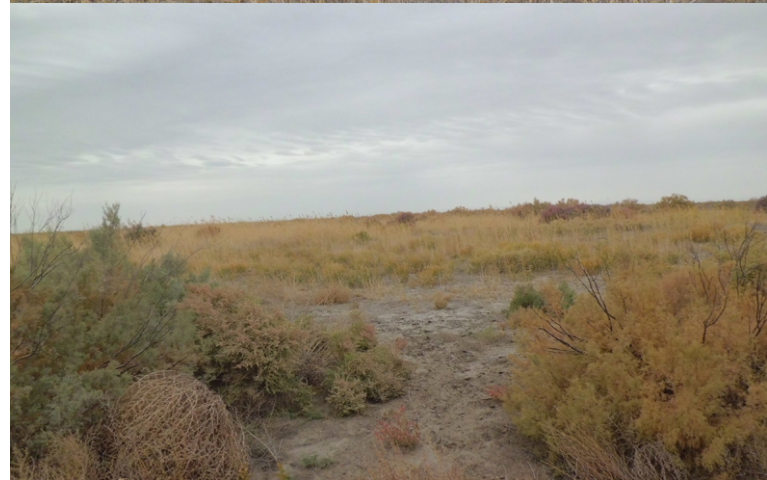
**Point 1474.** The terrain is flat; the soil is dark sandy. Tamarisk, reed, rare *Halostachys*, wormwood, *Climacoptera Botsch* and saltwort are found. Tamarisk reaches 0.5-3 m in height. Saltwort covers 95%. The terrain is open and flat; the soil is crusted solonchak. The channel passes between **points 1518 and 1519.**

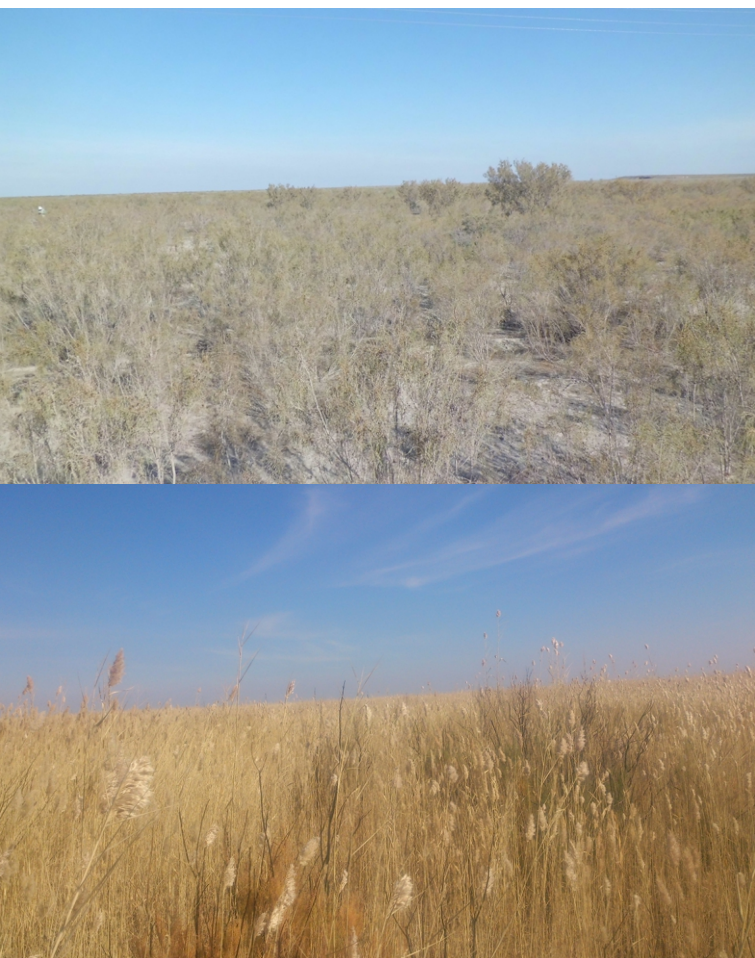
**Point 1590.** Flat field, with soil subsidence along the road. *Halostachys* is found rarely.
